## Case Report

### Management of a Broken Instrument in the Middle Third of the Root Canal of a Maxillary Central Incisor-A Case Study

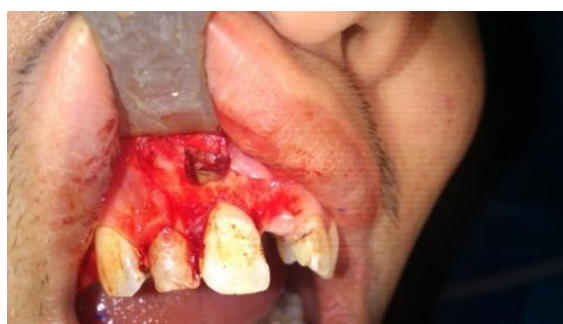
**Figure 2: Apex of the Root after Resection**

to access the periapical area via a retrograde approach. Subsequently, 2 mm of the root apex was resected using a fissure bur, with the bur oriented at a 90° angle to the long axis of the tooth. Figure (2).

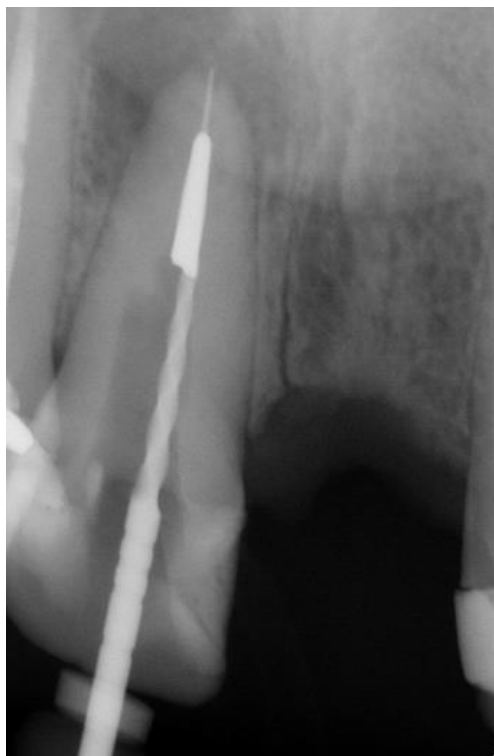
**Figure: 3A- Radiograph showing the fractured instrument in the root canal**

Then circumferential filing was started around the broken instrument while employing both orthograde and retrograde irrigation with normal saline under controlled pressure. Owing to the firm engagement of the fractured instrument within the canal, the procedure was repeated several times to enlarge the space between the canal walls and the broken fragment. This approach facilitated gradual loosening of the fragment and promoted its coronal displacement. Once sufficient mobility was achieved, the fractured instrument was successfully retrieved through controlled coronal manipulation Figure(3A&B). The canal was filled & the flap sutured. Figure (4)

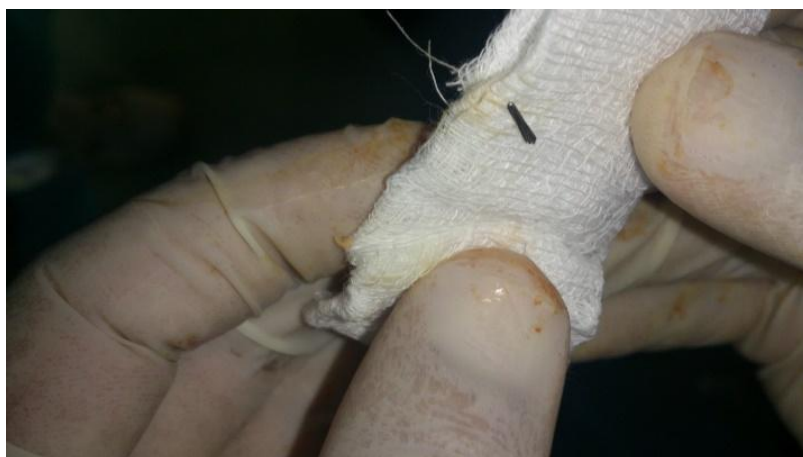
**Figure: 3B Endo Z bur**

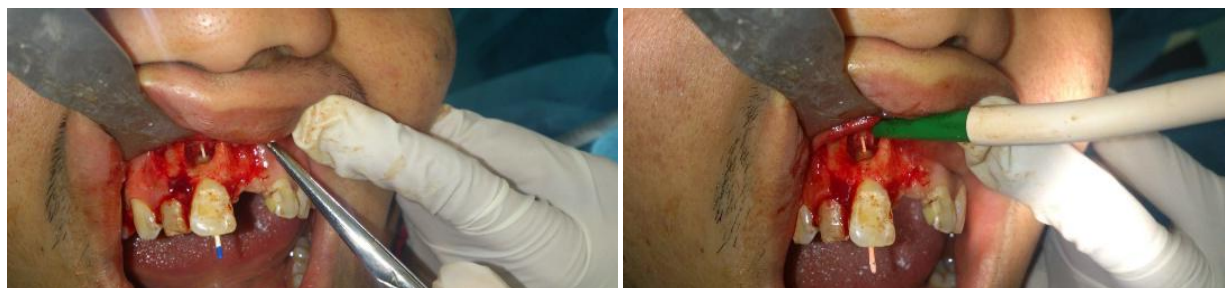
**Figure: 4 Surgical retrieval of the fractured endodontic instrument from the root canal**

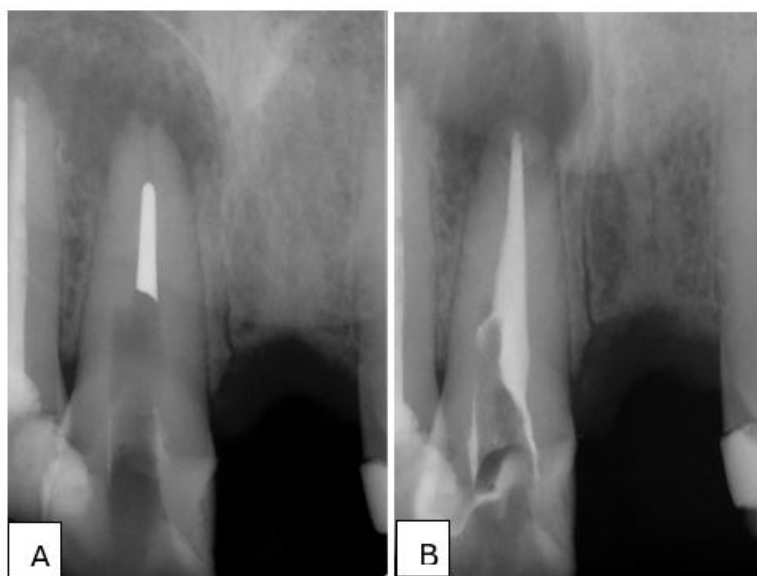
**Figure: 5 showing the tooth11 with separated instrument (A) & (B) after the canal obturation**
